**IEPA - DIVISION OF WATER POLLUTION CONTROL
DIGITAL PHOTO REPORT**

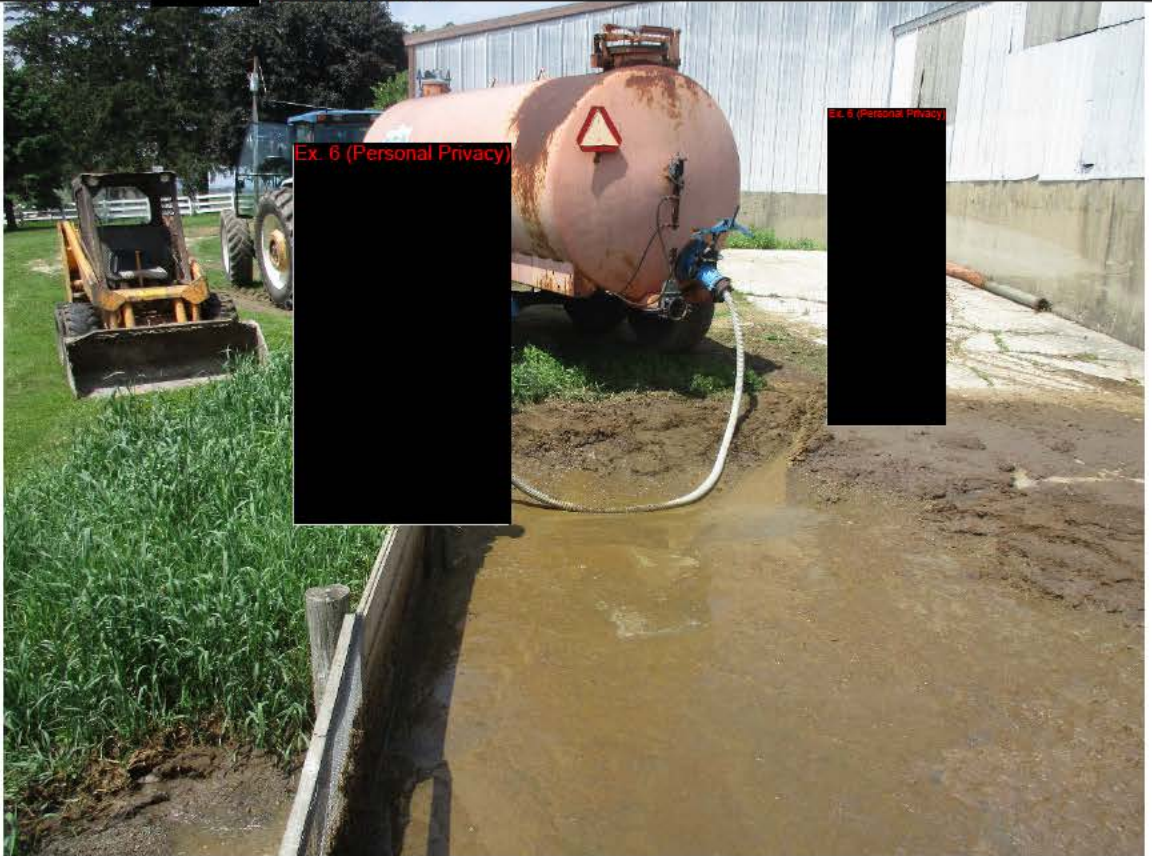
County: Jo Daviess	
Comments: A view of facility personnel pumping the wastewater into the tank wagon.	
Photo #: 7	
Photo Title: 053118 Ex. 6 (Personal Privacy) LH(8)
